BIKE MODEL - CRADLE Improving Solution

A4050 Set Assemble Status

Cradle Improving

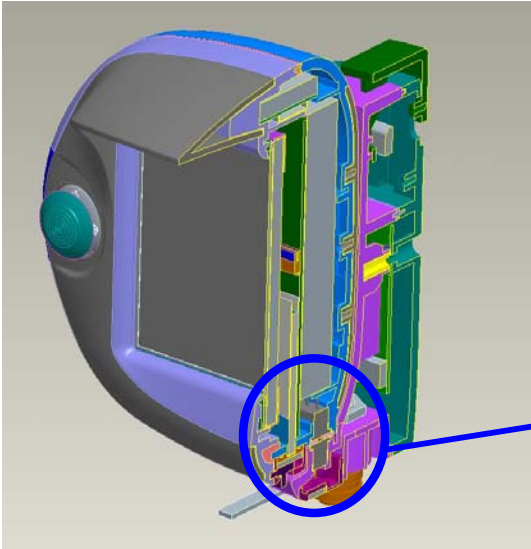
Current

When the A4050 set and Cradle assembled, the contacting area was 1mm since there was original 1mm gap from the HW set already.

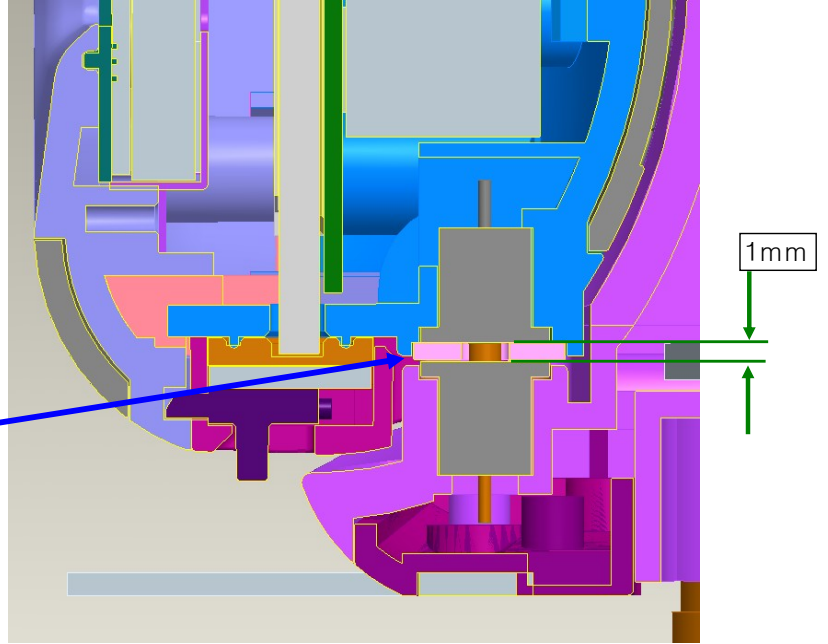
After Improving

After improving the pin length with additional 0.3mm longer, the contacting part from A4050 set and cradle pin gets 1.3mm. It makes stable connection & power supply.

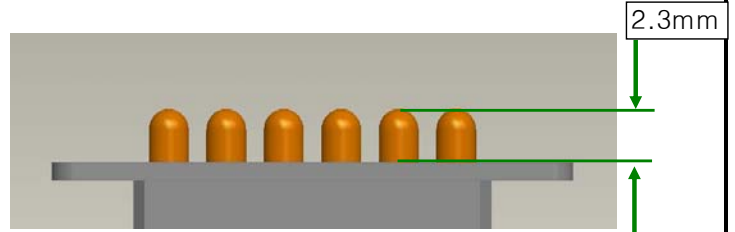
150 gf : With strengthen tension, it's improving of any contacting defective during big vibration.
